Update Rapport Configuration Settings - Avimark

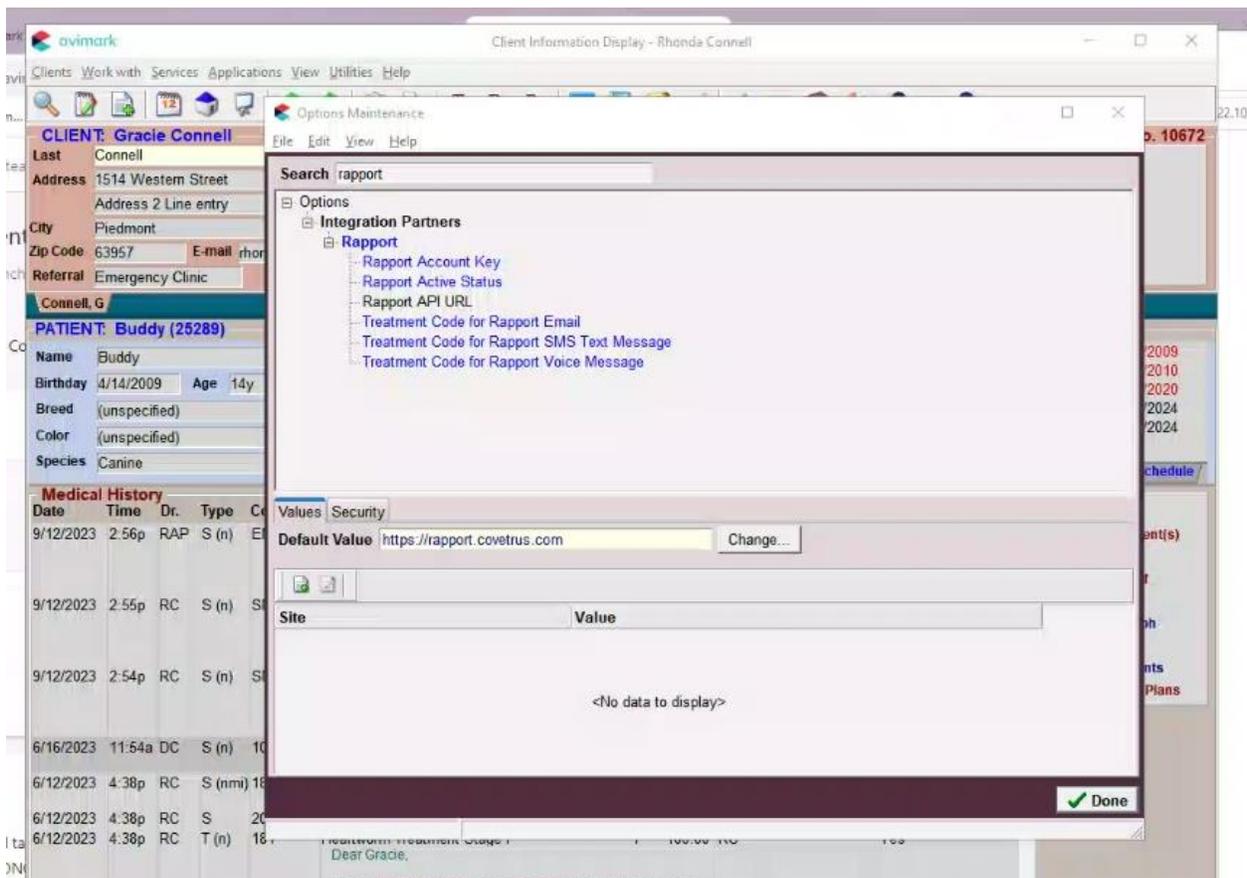
Rapport subscribers that receive an SSL error in Avimark when sending ODM (email or text) must update the API URL within Avimark settings.

2. Search "Rapport"
3. Select the Rapport API URL and change the default value from <https://rapport.appointmaster.com> to <https://rapport.covetrus.com>.
